Sandia National Laboratories/New Mexico

PROPOSAL FOR
CONFIRMATORY SAMPLING NO FURTHER ACTION
ENVIRONMENTAL RESTORATION SITE 112
EXPLOSIVES-CONTAMINATED SUMP
OPERABLE UNIT 1335

May 1997

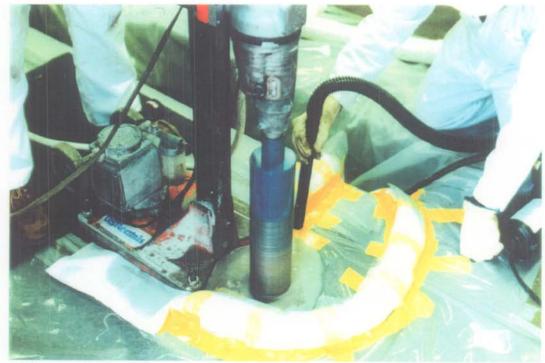
Figure 3-1. Concrete Coring Operations During Sampling

In June 1996, the 1-foot thick concrete floor of the addition was cored, then three boreholes were drilled and sampled in the former breezeway area where the sump was originally located (Figures 2-1, 3-1 and 3-2). The boreholes were drilled and sampled according to the procedures described in the OU 1335 site-specific sampling and analysis plan (SAP) with the following exceptions:

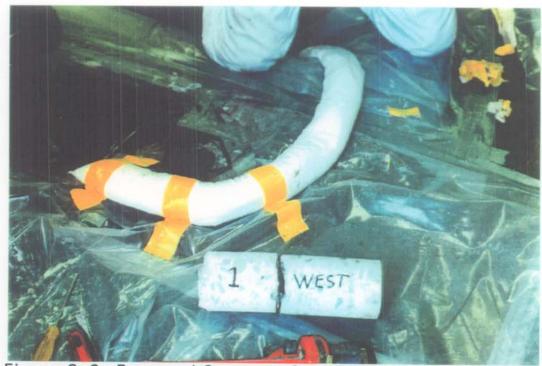
Figure 3-2. Removed Concrete Core and Sampling Borehole

- (1) No visible evidence of soil contamination, staining, or discoloration was observed during the confirmatory sampling event. However, because of a strong odor detected during sample collection activities, the headspace in the sample jars was screened for volatile organic compounds (VOCs) using a photoionization detector (PID). The PID results are summarized in Table 3-1. VOCs were detected in borehole BH-1 (3-5 foot depth interval 35 units over background) and at the 6-8 foot sampling depth interval (0.04 units above background). No VOCs were detected in samples from BH-2 or BH-3. Because of the PID anomalies, the decision was made to collect samples for laboratory VOC analysis. These analytical results are discussed in Section 3.2.2.1.
